## **25. Crushed Between Two Vehicles**

A **36-year-old** mechanic was crushed between two vehicles while changing tires on one of the vehicles. A truck was placed in one bay of the facility and new tires were placed on the rear axle. After servicing of the truck was complete, several attempts were made to start the truck so it could be removed from the bay. Starting the truck started was unsuccessful and two co-workers of the victim tried other methods to start the truck. Ultimately, one co-worker used a remote starter tool on the truck's solenoid while the other co-worker held a flashlight for him. By doing this, they bypassed the neutral safety switch located between the ignition switch and the starter. After hitting the remote starter button multiple times, the truck finally started and moved in reverse. The neutral safety switch was installed by the manufacturer to limit the ability of an automatic transmission to start in any gear other than park or neutral. While this was occurring, the victim was standing in the same bay at the engine area of a van and lifting the front to prepare it for new tires. The van was approximately 20 feet behind the truck. When the truck moved in

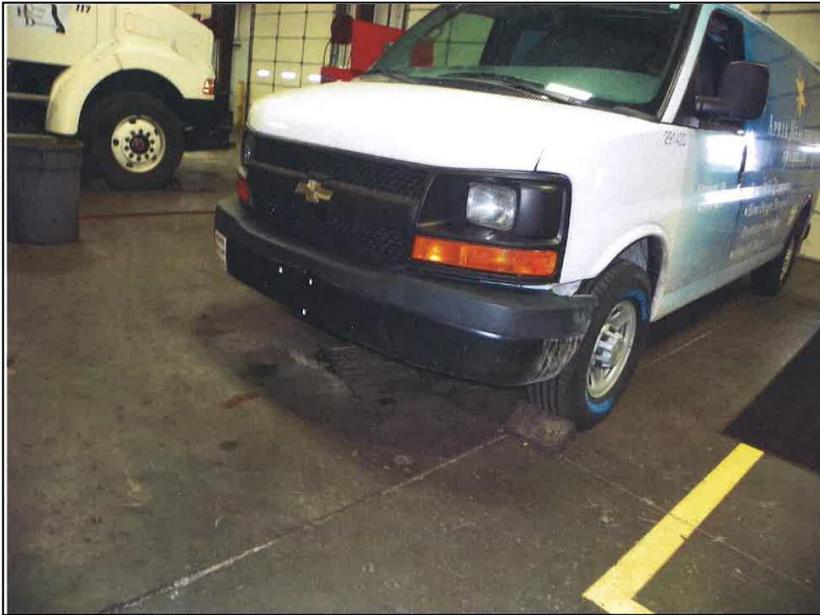
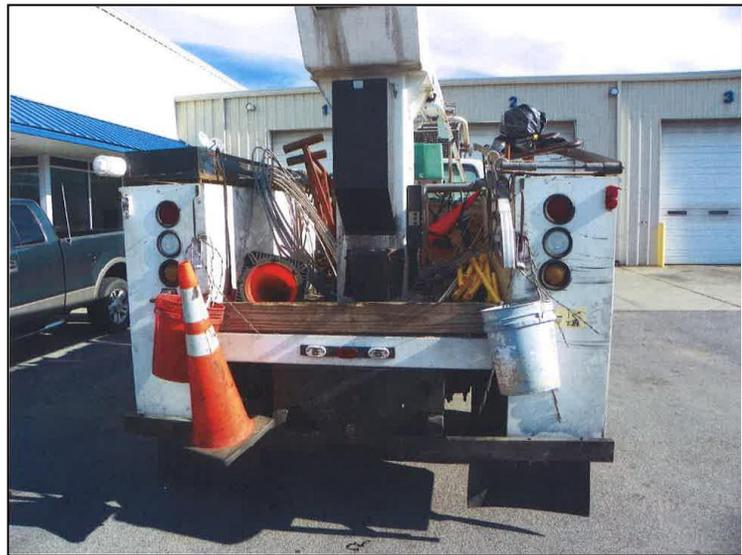
The victim was crushed between the back of the truck and the front of the van
